Cisco TelePresence System Codec C-Series

Software release notes TC4

D1475503

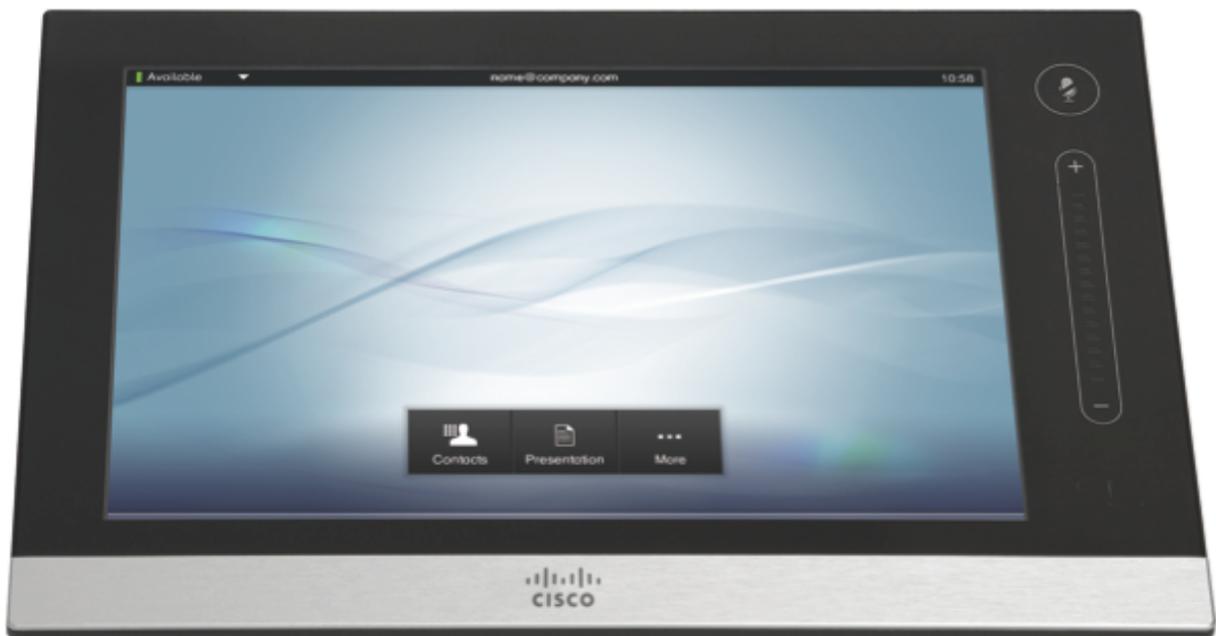
You'll quickly see how easy and effortless it is to use:

- Simple set-up – one cable connection to network
- Reduced learning curve – clear, context-based interaction
- Easy to connect – select from list of video endpoints
- Seamless collaboration – select the device you want to share
- Consistent experience – shared experience with the immersive Telepresence T3/T1

Note: The Cisco TelePresence Touch screen requires software version TC4.1.0 or later.

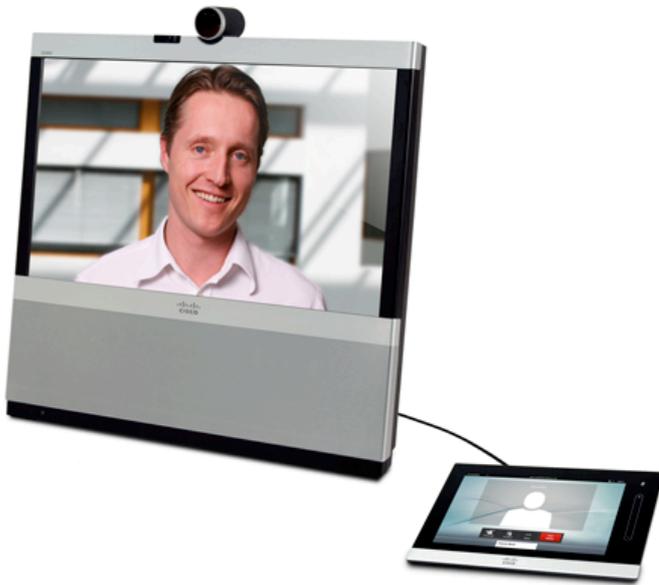
The TC4.0.0 release introduces support for the new Cisco TelePresence System EX60, personal TelePresence for knowledge workers.

The Cisco TelePresence System EX60 is ideal for individual contributors and knowledge workers throughout the organization – bringing the power of TelePresence to the desktop or cubicle as an “always available, anytime” resource.

Note: The Cisco TelePresence System EX60 requires software version TC4.0.0 or later.
